**SOME INFORMATION ABOUT
GEOTECHNICAL ASPECTS OF
PISA TOWER STABILIZATION**

ing. Nunziante Squeglia
squeglia@ing.unipi.it

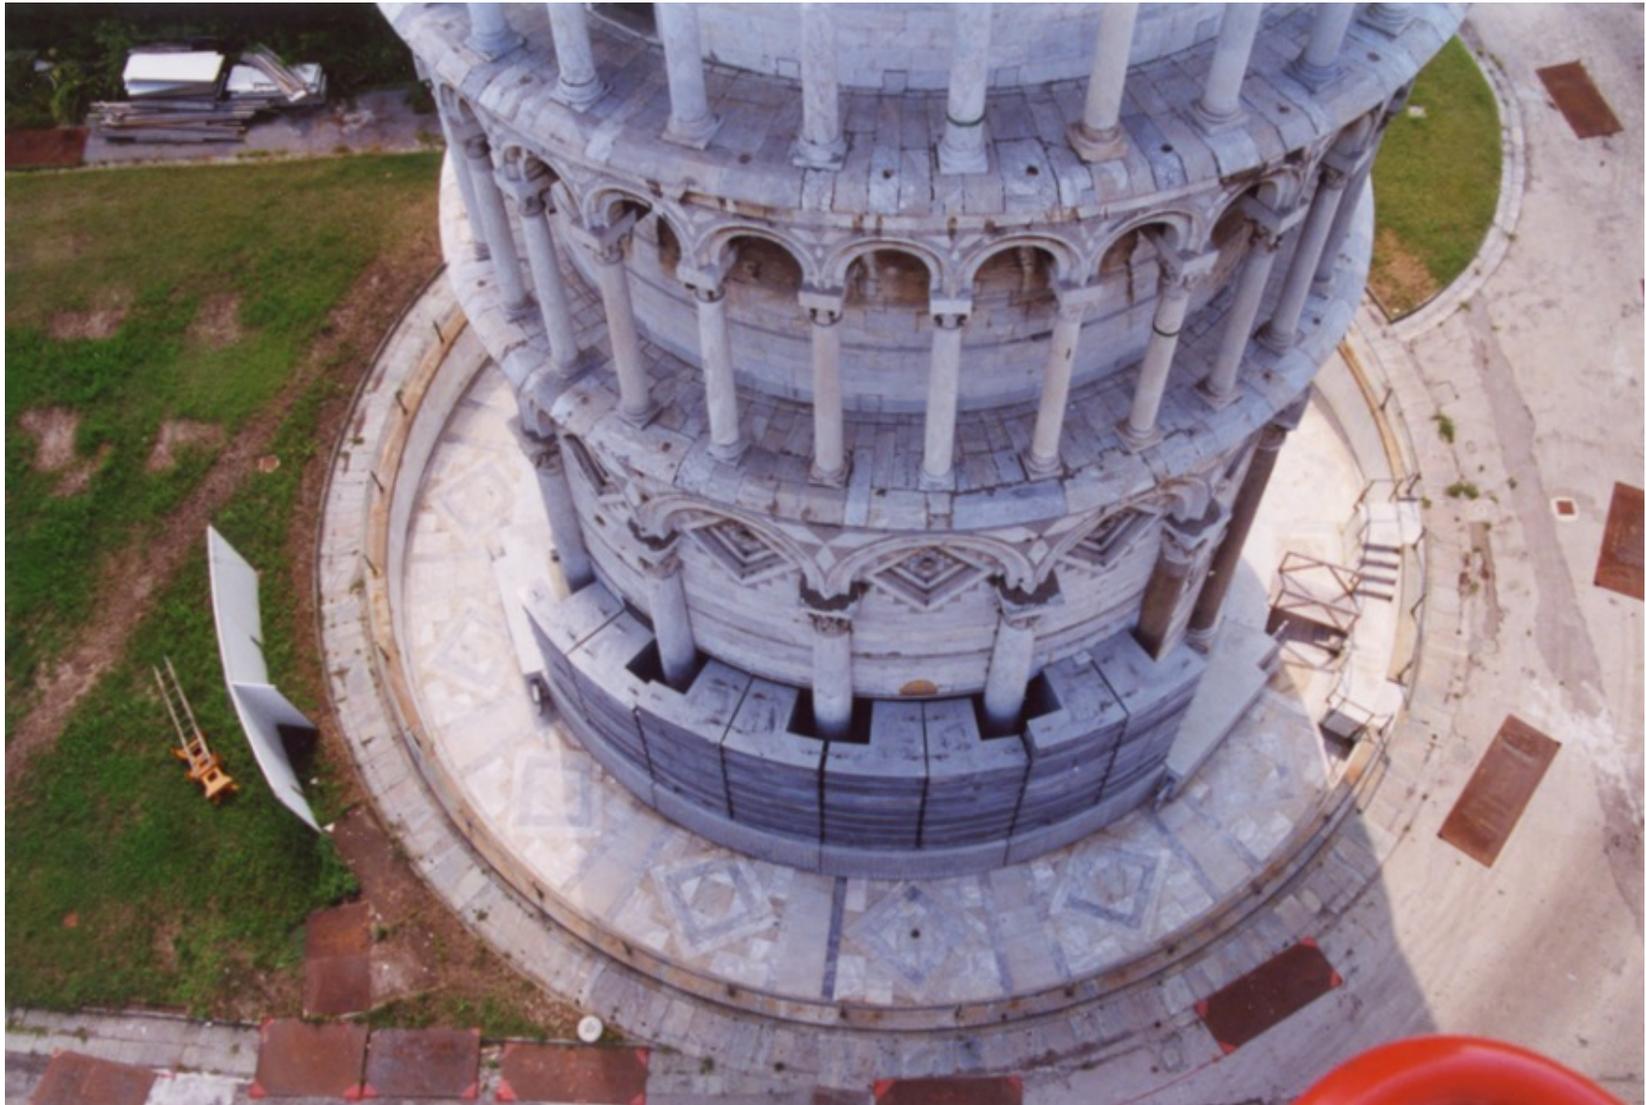
Effects of lead ingots installation

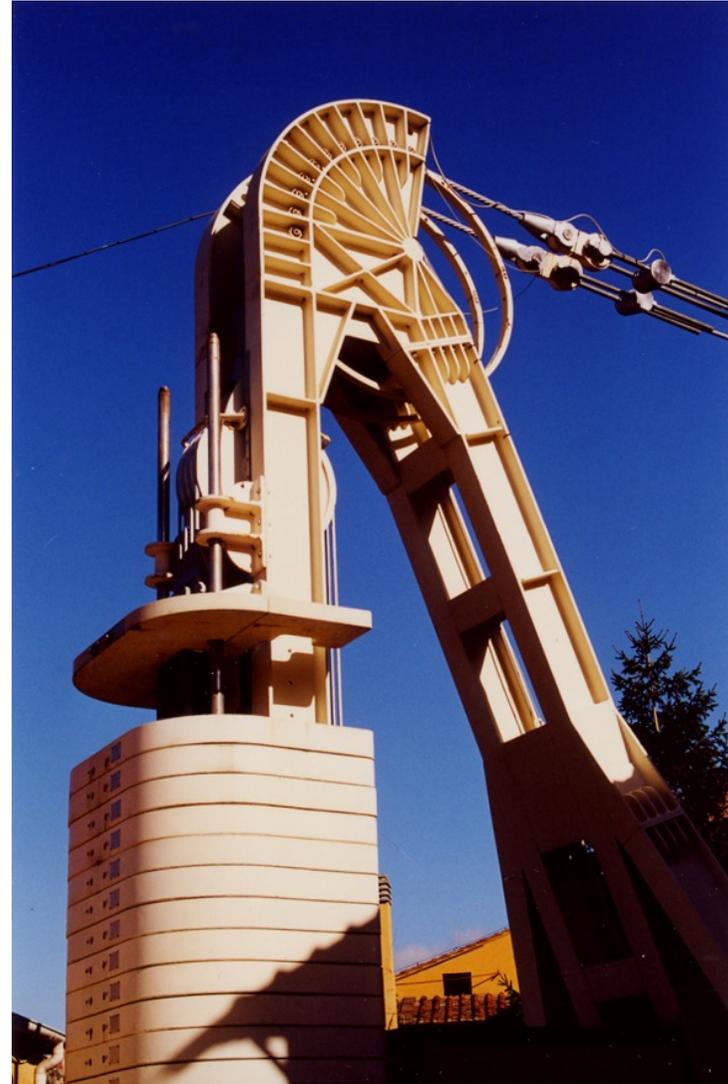
**It is conceived as a force,
not a restraint**

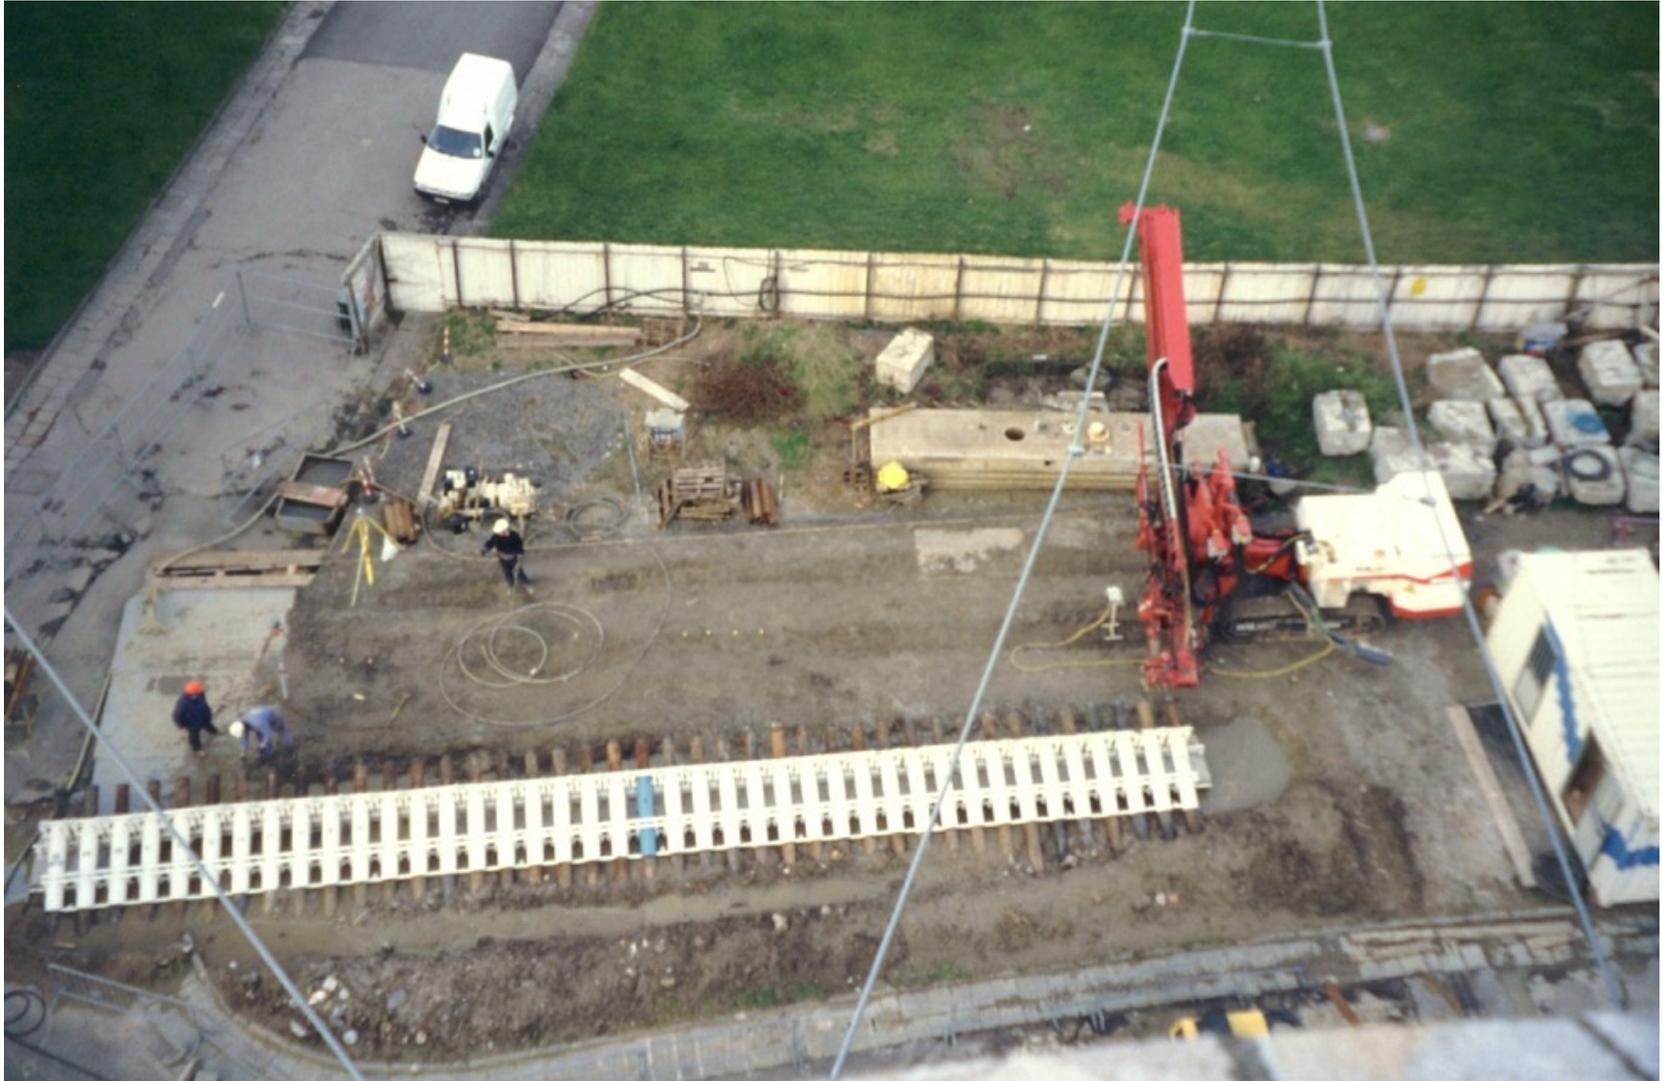
Second phase:

- 41 boreholes
- inclination 20°
- auger always in place
- side extractions

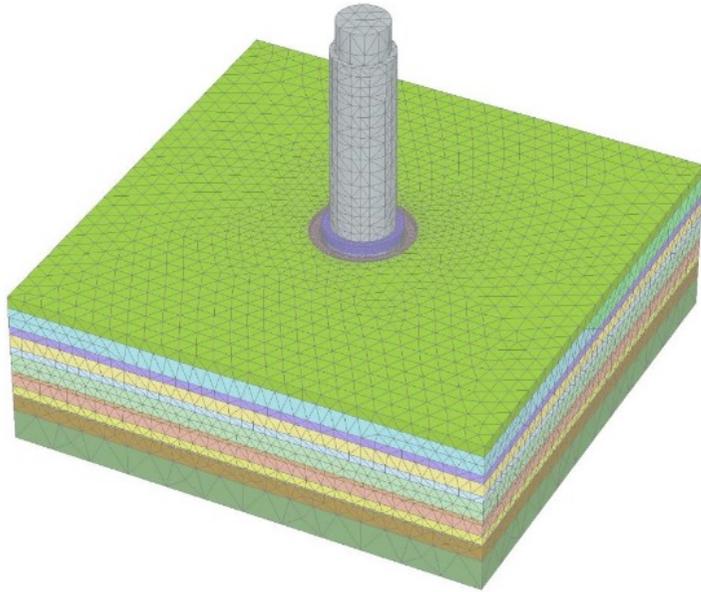
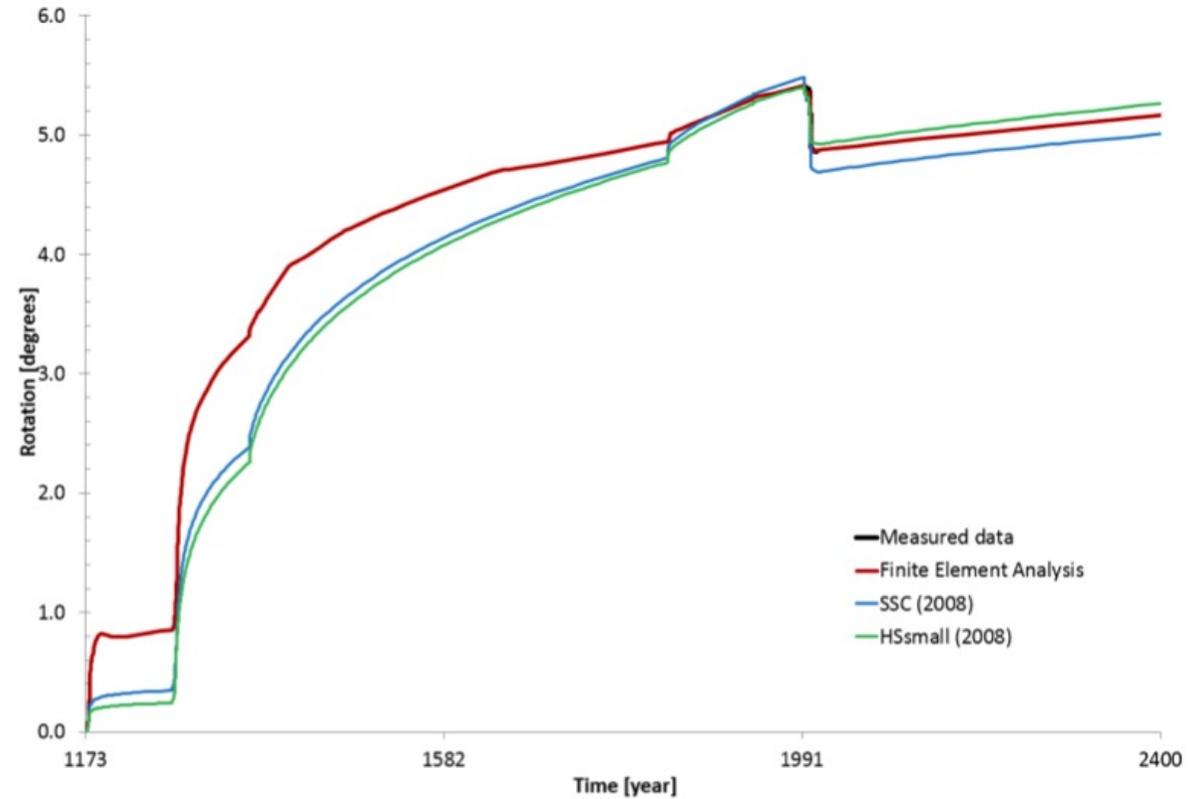
Finite Element Model
