EGO Council meeting

18-12-2023

General Infrastructure Building Damage Report

Interferometer Damage Report

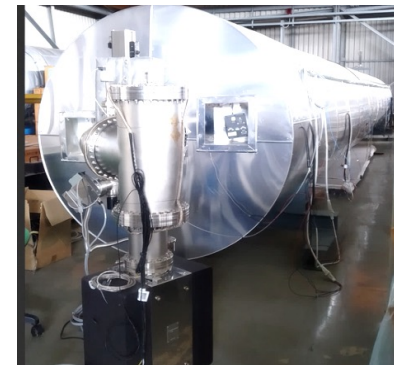
Lab activities

- Testing New Pumps for Adv+II on large chambers
- Characterizing dust in vacuum chambers
- Outgassing tests

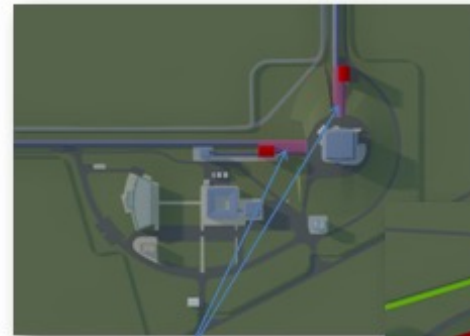
Stable Recycling Cavities Design

Preliminary evaluations considering the optical layout discussed in 2010-2011

2 new experimental buildings hosting PR2 and SR2 towers

Adjustment works for the CB N&W Galleries and the initial part of N&W Tunnels

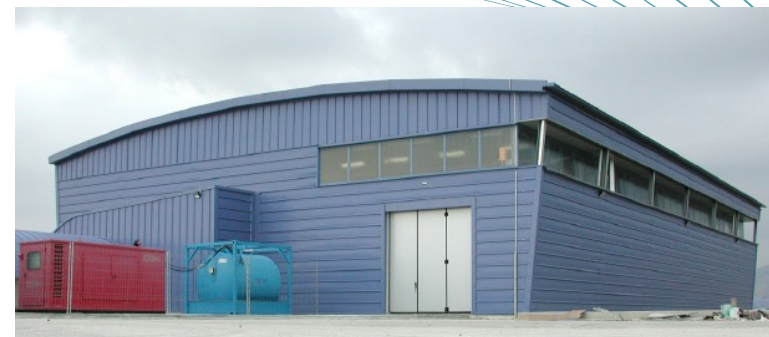
Initial photovoltaic system for the production of electricity installed in March 2023 on the roof of the Office Building (power: 20kWp, energy production: 24MWh/year).

- plant on Main Building roof (power: 50kWp, energy production: 63MWh/year).
- plant on 1500W Building roof (power: 100kWp, energy production: 123MWh/year).

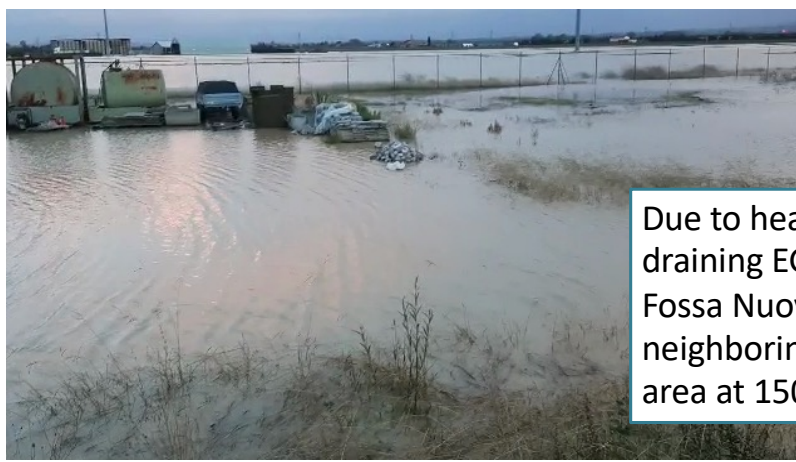
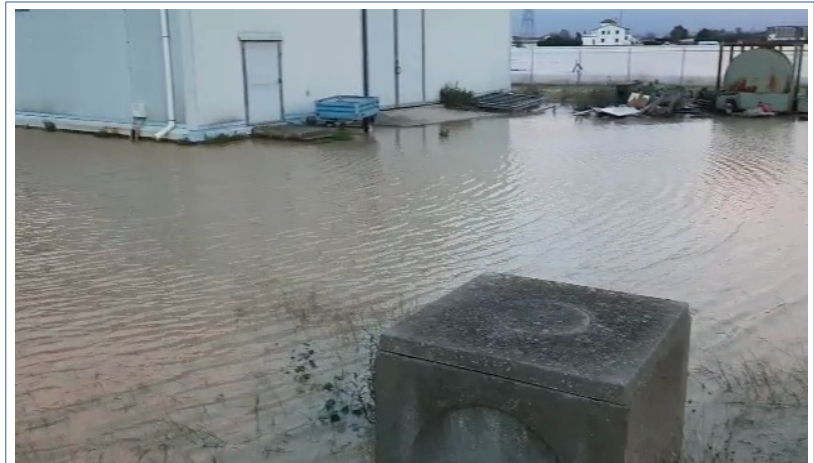
Due to heavy rains, the main ditches draining EGO Area (Fosso Solaiola, Fossa Nuova) overflowed the neighboring fields and flooded the area at 1500 N (photos 1, 2, 4)

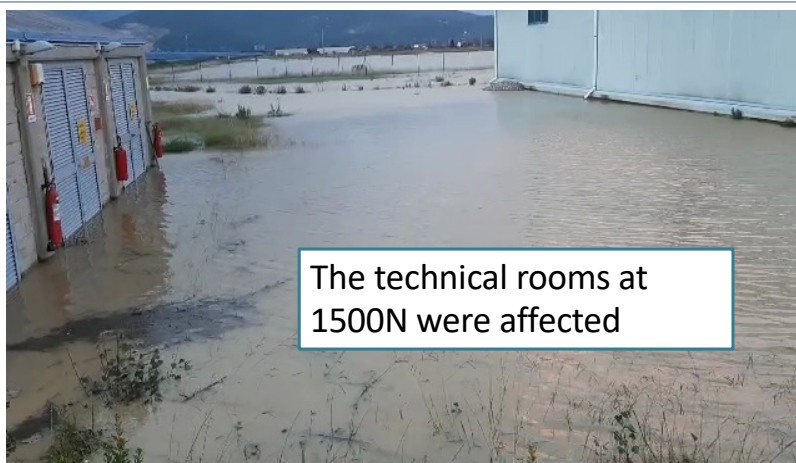
Photo 3

The technical rooms at 1500N were affected

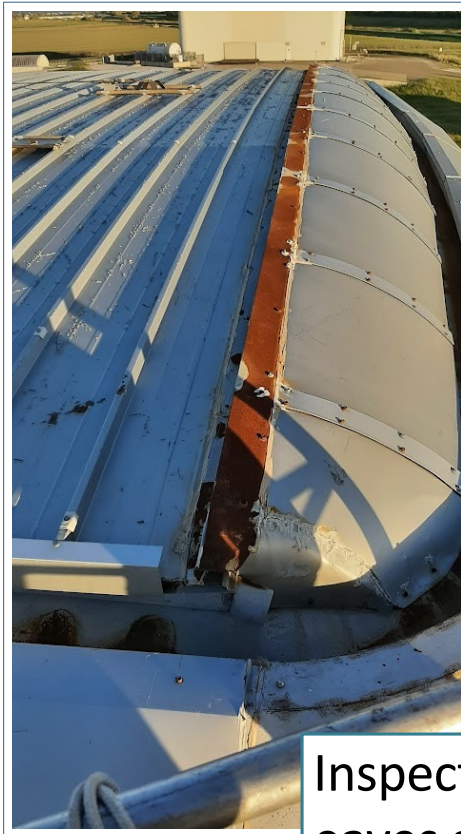
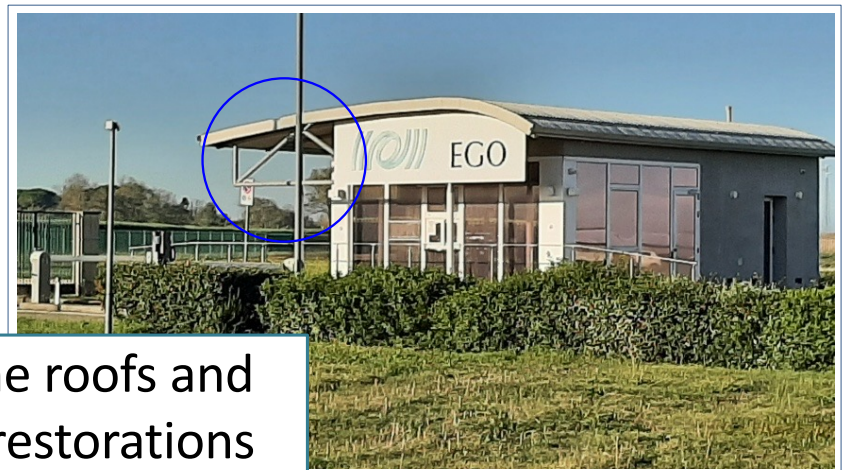
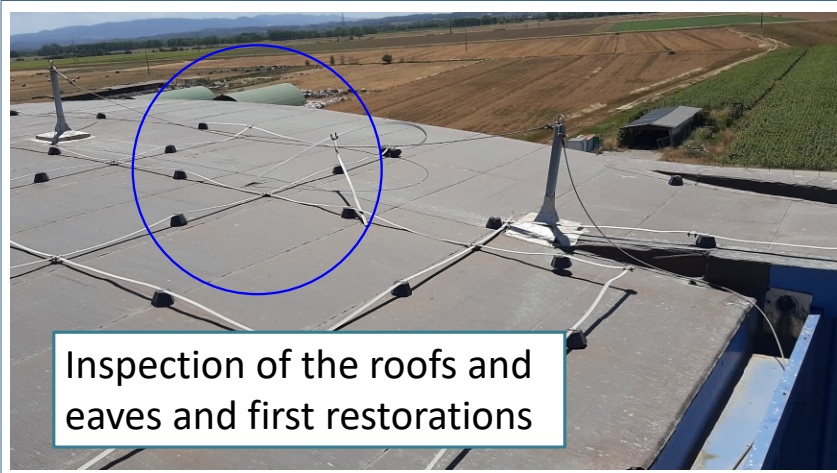
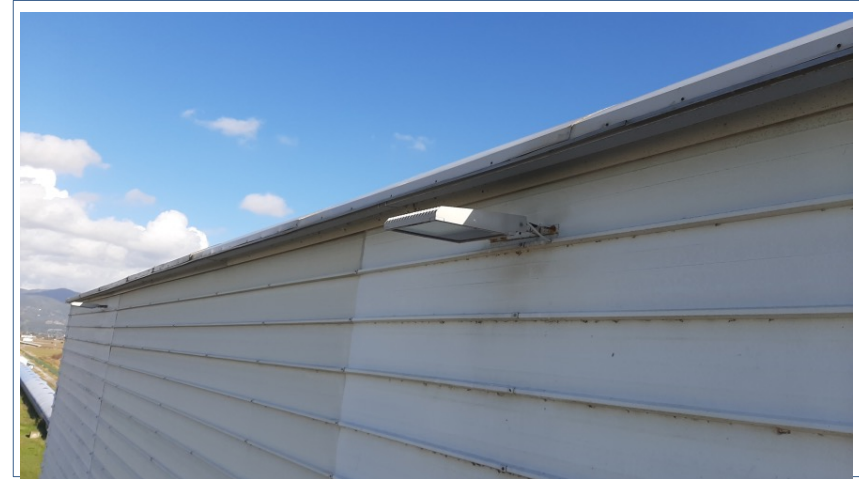
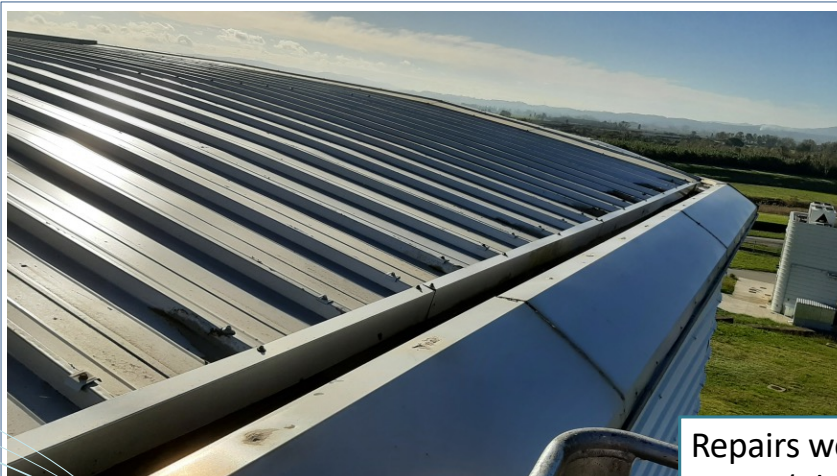
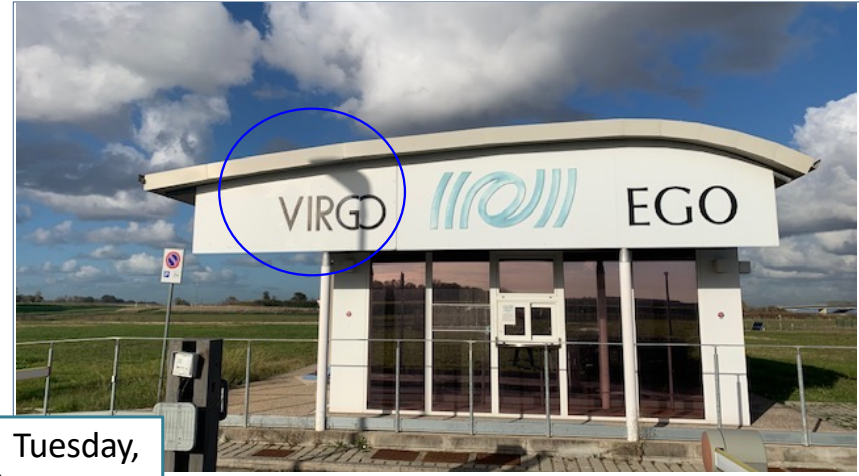
Inspection of the roofs and eaves and first restorations
